Manhole Inspection Summary

Manhole # S23A__001MH

Location Address: **621 VINCENT ST**

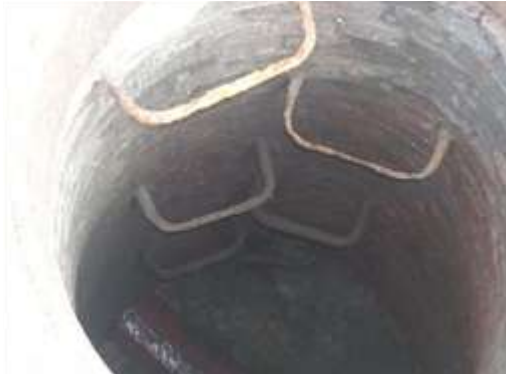
Defect 2

Steps Count: **6** Missing: **0** ☒ **Corroded**

CORRODED STEPS

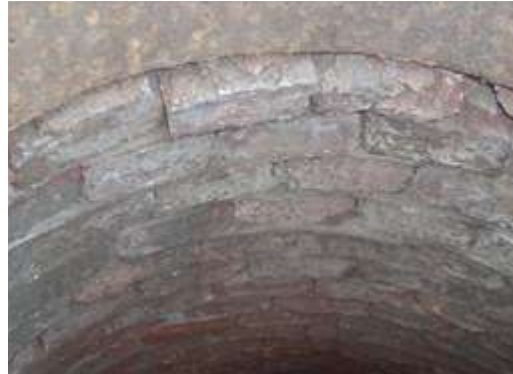
Defect 1

Condition: ☐ Sound ☐ Cracked ☐ Root Intrusion ☐ Loose Brick ☒ **Deteriorated**

DETERIORATION OF CORBEL

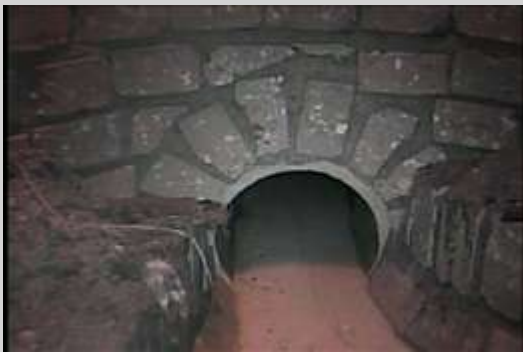
12 O'Clock Outflow

DETERIORATION OF CORBEL

Pipe Height: **8.4** (in.) Rod and Bar (Angled)
Pipe Material: **Clay** ☐ Pipe Lined
Invert Depth: **10.54** (ft.) Flow Characteristics: **Slow**
Deposits: ☐ None ☒ **Mud** ☐ Sludge ☐ Debris ☐ Grease
Silt Depth: **2** (in.) Deposits Extent: **Medium**
Infiltration: **None** Pipe Seal Cond: **Sound**

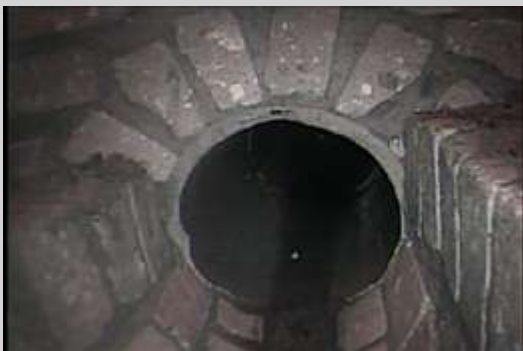
3 O'Clock Inflow

DETERIORATION OF CORBEL

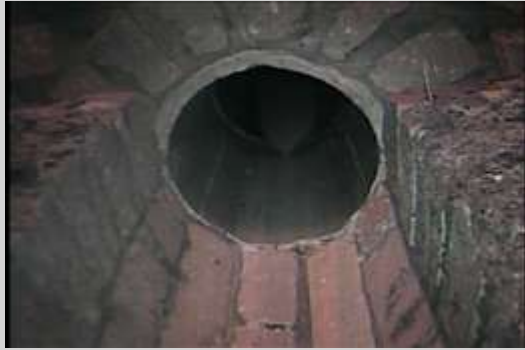
6 O'Clock Inflow

DETERIORATION OF CORBEL
